The wall paintings on the first state floor

Stella Boj, Giacomo Causa

The state of preservation

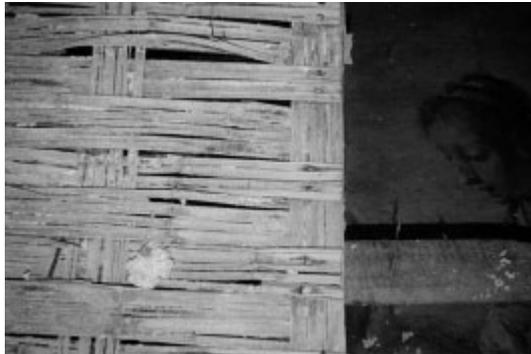
1. Detail of Bernardo Strozzi's frescoes, portraying Faith, under the reed matting in palazzo Nicolosio Lomellino in Genoa.

In the days following, slowly but surely the view of the part of the painting preserved under the wooden structure grew larger (fig. 1), the scene that could be seen was covered in numerous spiders' webs and in small groups of splashes of mortar, due to the installation of the plaster on the irregular reed support: as it happens, the part concealed under the false vault was exactly the one depicting the protagonists of the story.

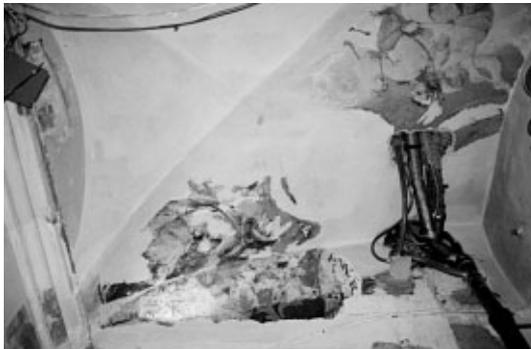
2. Room of the Allegory of the Faith in palazzo Nicolosio Lomellino in Genoa, part interested by repeated dull layering to cover the fresco.

Completed the total removal of the wooden structure and then the plaster covering the painting, almost the whole work of Benardo Strozzi could be seen, especially its bright colours and cleverness of the markings and brushstrokes. Of the three rooms overlooking via Garibaldi, this one, that before the stratigraphical research had, like the other rooms, a vault without lunettes fitted on to a cornice, is the one which is the best preserved, if the changes made at the beginning of the eighteenth century are excluded: the room was reduced and, thus, also the vault was shortened to leave room for the monumental staircase. At this stage three lunettes and two pendentives on one side were lost for good, while on the opposite side the original size of the room can still be made out. In this space a store room was fitted afterwards for the use of the service stairs; thanks to this internal use parts of the sixteenth century decorated cornice have been maintained and the relative part of the vault: here, where the two lunettes and the two pendentive domes saved underwent continual re-paintings, the almost total adhesion of the pictorial film to the layer covered in lime base (dulling of the fresco) was noticed (fig. 2).

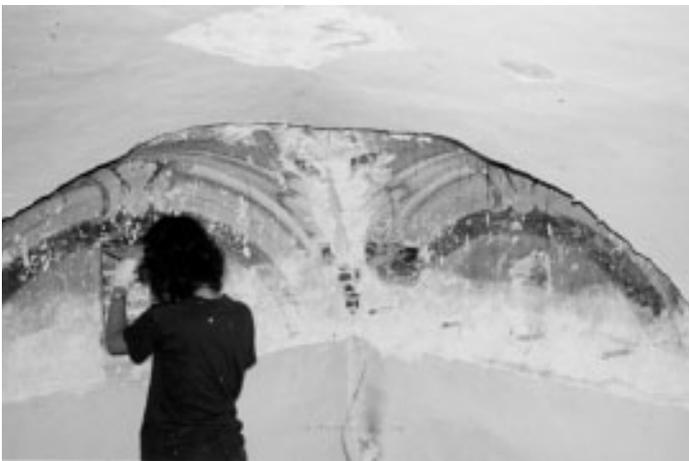
3. The restorer works on the lunette recently reappeared in the room of the Allegory of the Faith in palazzo Nicolosio Lomellino in Genoa.

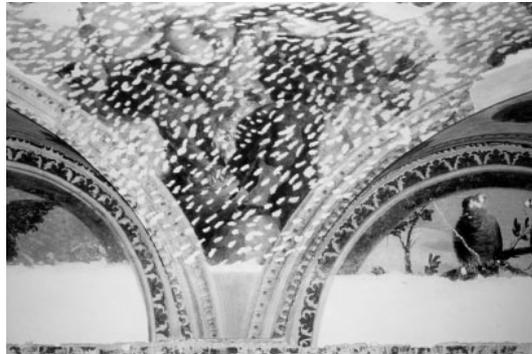
6. Mask in the Astrology Room in palazzo Nicolosio Lomellino in Genoa during the restoration

The long and delicate phase of the removal of the lime dull covering allowed to bring to light very important details, in both the central panel and the contour motifs: especially a mask, studied more in depth by the artist, first it was sketched by pencil, then with a brush, finally shaded in the main shadows. The beating of the thread, still recognisable, was needed for the quick construction of the two specular halves (fig. 6).

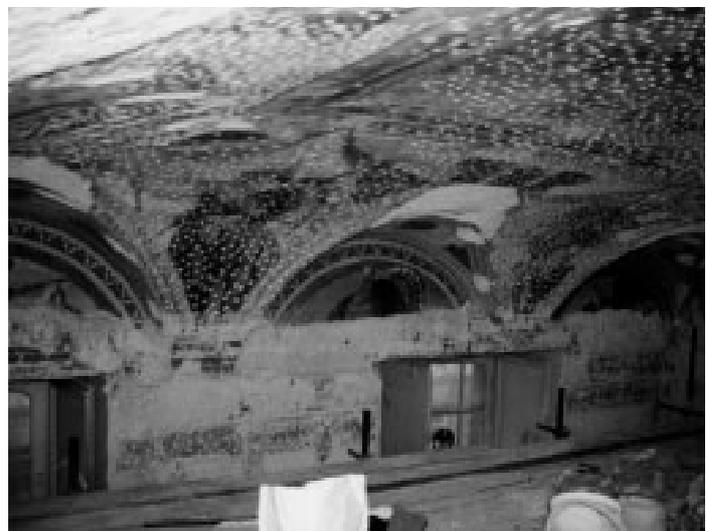
4. Pendentives with fishing scenes and lunette with parrots in the Room of the Allegory of the Faith in palazzo Nicolosio Lomellino in Genoa during the restoration.

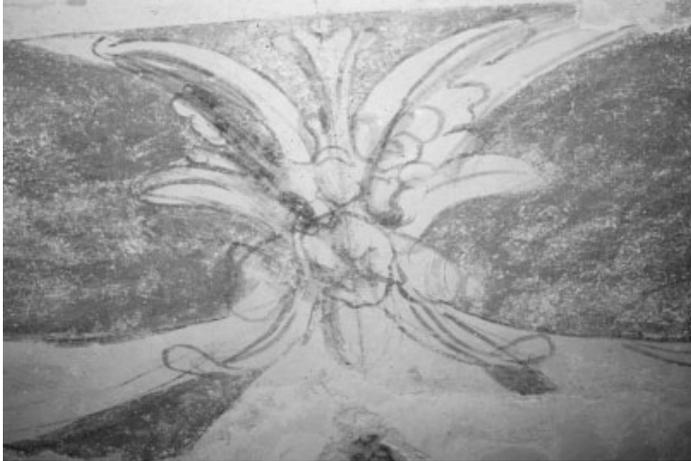
5. Detail of the vault of the Room of the Allegory of the Faith in palazzo Nicolosio Lomellino in Genoa.

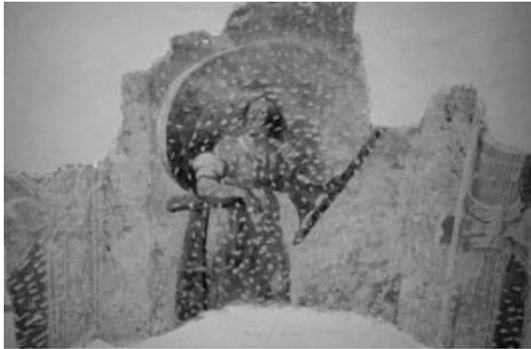
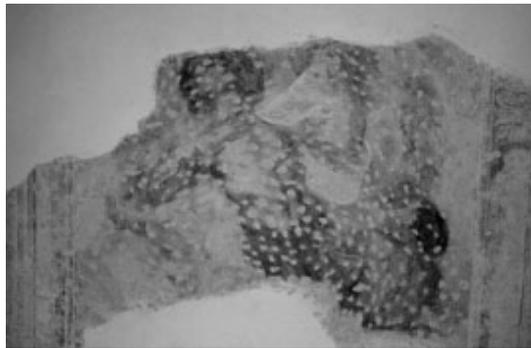
7-8. Detail of the Room of Navigation and of the tritons in palazzo Nicolosio Lomellino in Genoa, during the restoration

The third room, which has a window looking on to via Garibaldi and two on to Vico Lurago, is the result of the union of two adjoining rooms: following the structural changes, it has kept a section painted by Strozzi, with an allegorical female figure on a marine background, and an area portraying other characters all concerning navigation, but with diverse stylistic and material characteristics (figs. 7-8).

On the other hand, the archeometric analyses have confirmed what the strong inflection at the centre of the vault, the measurements of the lunette so different and improbable and the obvious detachment of the wall decoration had led us to suppose: the structural foreignness of the two painted sections.

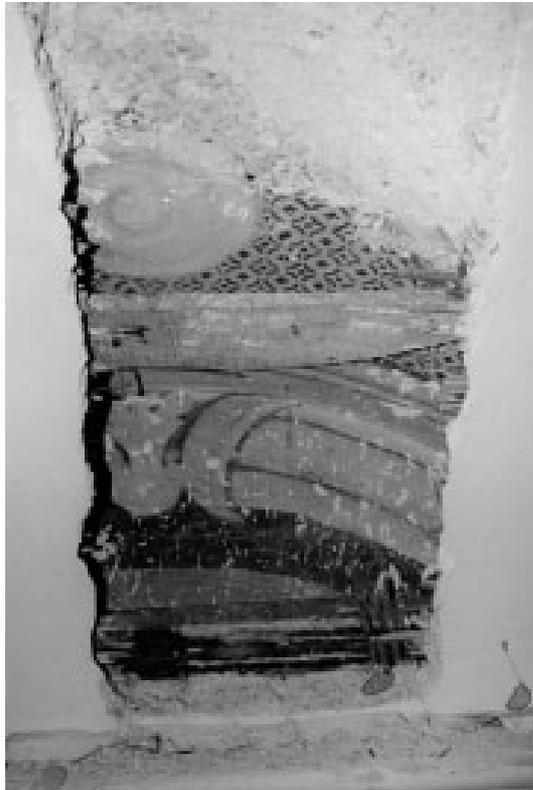
4. The rediscovery of a lunette, Genoa, palazzo Nicolosio Lomellino, first state floor

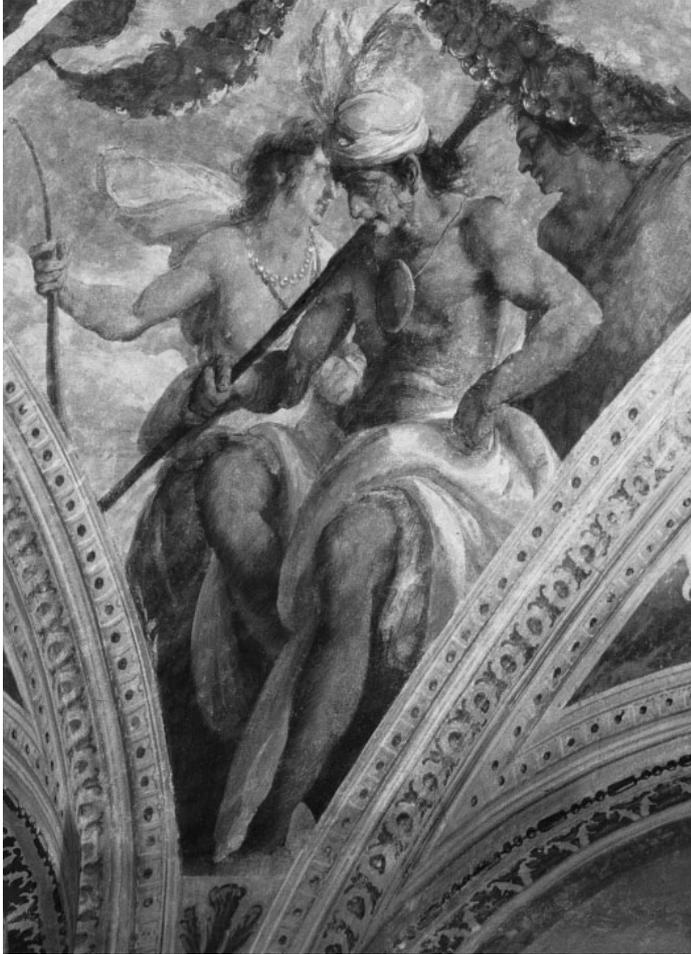
9. Bernardo Strozzi, *Allegory of the Faith* (detail), 1623-1624, Genoa, palazzo Nicolosio Lomellino, pendentive domes with retouching in brush lined strokes.

be ascribed to the mechanical action of the stakes, also to the extremeness "smoothness" of the plaster which being polished, brings a large quantity of lime to the surface caused by the crushing made by the probably metal instrument used: this "compacting" action, takes away the fixing agent from the bottom layer, making the support weak (fig 9).
